FULL SCALE LOAD TESTING TO FAILURE
OF A.R.C RIGID FRAME TYPE BRIDGE

Public Works Department, Malaysia

ABSTRACT

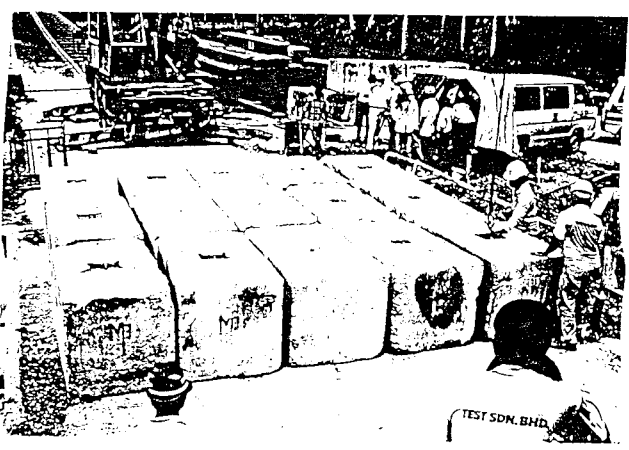
Figure 6: Scene of load test at 51.4 Tons

For stage 2 testing, it was originally proposed that two concentrated loads of 1.8 m apart be applied against a kentledge of concrete blocks to simulate the PWD standard wheel loads (1990). There was however a difficulty in the design of the testing rig which had to span across the length of the bridge. It was therefore decided that concrete blocks be used as dead load instead. The loading was applied over an area of 6.3 x 5.8 m (see figure 6) using two 30-ton cranes. One crane was used for the placement of the concrete blocks while the other was used to hoist up a worker to help position the concrete block in place. The precaution taken had proved to be necessary when at one stage of the loading the loading block fell down. The strains and deflections were recorded for every 20 tons load interval.

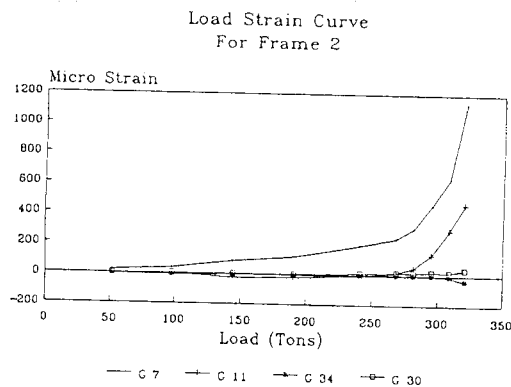
Figure 9b: Strain curve for gauges 7, 11, 34 and 30.

These two figures showed that, the wall at G7, G11, G17, G18, G25 and G26 entered the non linear load and strain relationship at 268 tons. The strain readings before failure, for G7 and G11 indicated that they are in tension and the bottom walls are in compression.

It is also noted that, in figure 9a and b, the non linear phase occurred at loading of around 268 tons, earlier than that of the beams. This showed that the decks are very much stronger than the wall/column.

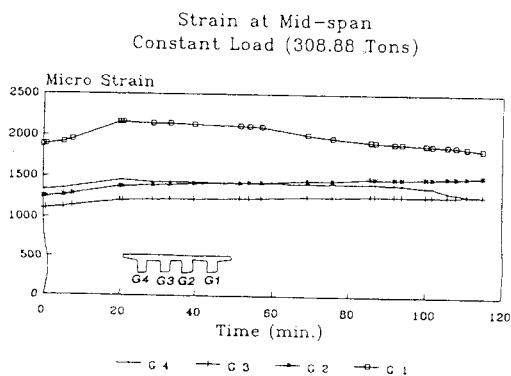
Figure 10: Constant load strain curve at mid-span, for beam 1 to 4.

At constant load of 309 tons, the beams are well into the non linear range. As was demonstrated by the curves in figure 8, the edge and its intermediate interior beam approached or are converging to the same strain. This can be clearly seen in the figure above, for gauges G3 and G4.

Under UDL load, the behaviour during the initial stage is similar to the to the truck loads as the structure is still in the elastic stage. Beam G1 is seen to be weaker than the other three beams, however after 282 tons, as the structure enters the non linear phase, the super structure began to demonstrate the load distribution patterns. As shown by the rapid increase in the strain of the other three beams as was shown by figure 8. The curve in figure 10 also showed that, the strain in the weaker beams are reducing and that of the

stronger beams are increasing, which indicate that load redistribution occurred.
